# Manhole Inspection Summary

Manhole # S45G\_\_041MH

Record Plat: **45G** Node: **041** Status: **New Manhole (Not in GIS)** Insp Date: **7/15/08 12:00 AM**

**Location** Address: **246 s washington st**

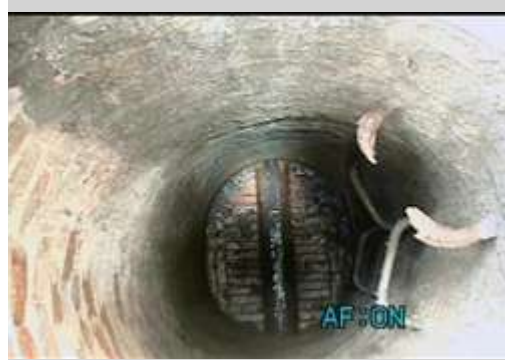
Top View

& steps

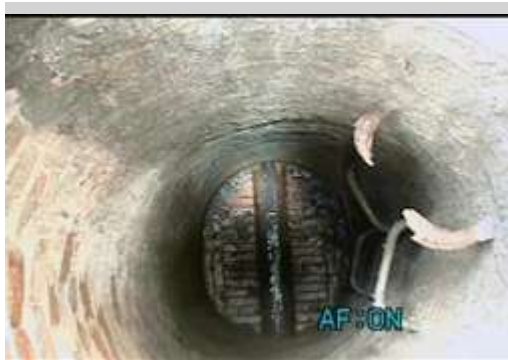
Defect 3

**Steps** Count: **7** Missing: **1** ☒ **Corroded**

corroded and missing steps

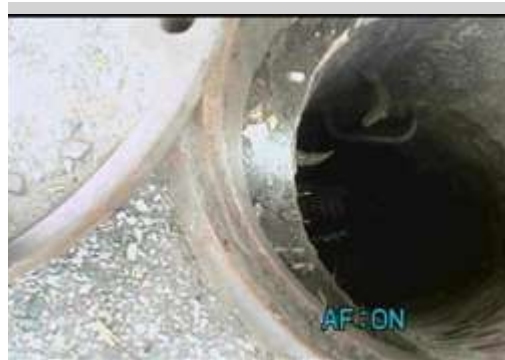
Defect 2

**Frame** Offset: **3** (in.) Condition: ☒ Sound ☐ Cracked ☐ Leaks

offset

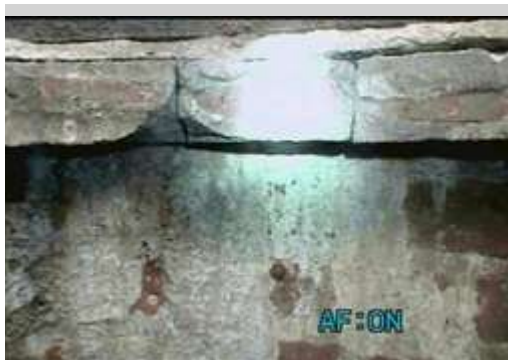
Defect 1

Condition: ☐ Sound ☒ **Cracked** ☐ Root Intrusion ☐ Loose Brick ☐ Deteriorated

chimney cracked, frame adj

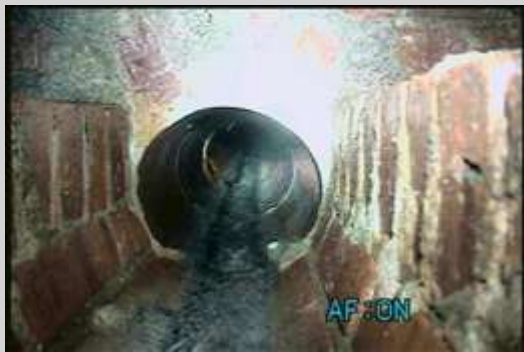
12 O'Clock Outflow

8 in. Circular Gravity Sewer  
Pipe Out @ 12 O'Clock

Pipe Material: **Clay** ☐ Pipe Lined

Invert Depth: **12.90** (ft.) Flow Characteristics: **Fast**

Deposits: ☒ None ☐ Mud ☐ Sludge ☐ Debris ☐ Grease

Infiltration: **None** Pipe Seal Cond: **Unknown**

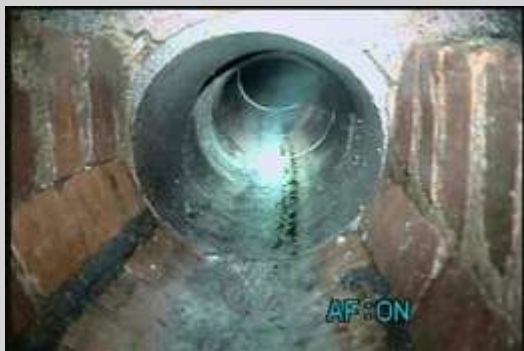
6 O'Clock Inflow

8 in. Circular Gravity Sewer  
Pipe In @ 6 O'Clock

Pipe Material: **Clay** ☐ Pipe Lined

Invert Depth: **12.75** (ft.) Flow Characteristics: **Fast**

Deposits: ☒ None ☐ Mud ☐ Sludge ☐ Debris ☐ Grease

Infiltration: **None** Pipe Seal Cond: **Unknown**
